REPORT

London Leisure Centre Pools

Inspection – 19th January 2009:-

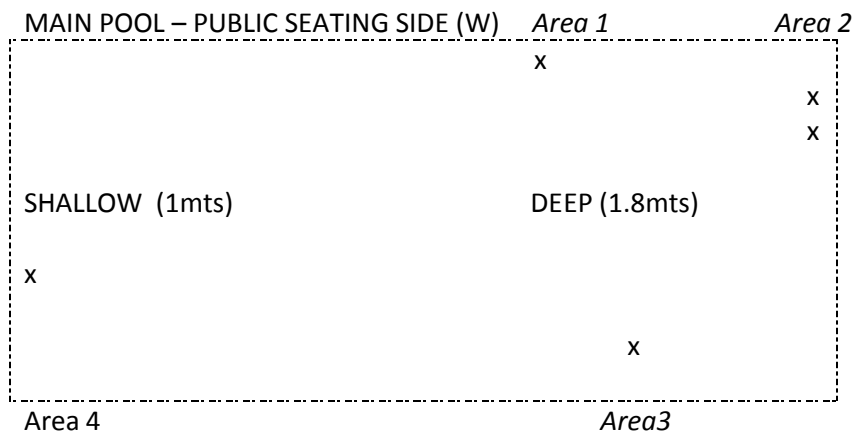
Area 4

In the area of and around the water inlet in the shallow end of the pool (E), the pool wall is bowing out by 55mm. When investigated by the removal of one tile, it appears that the render along this area has separated from the concrete main structure creating a gap – see photographs 4 & 5.
